# SAFETY BULLETIN

## Crane incidents on the rise

**Mine safety reference** SB22-04

**Date published** 5 April 2022

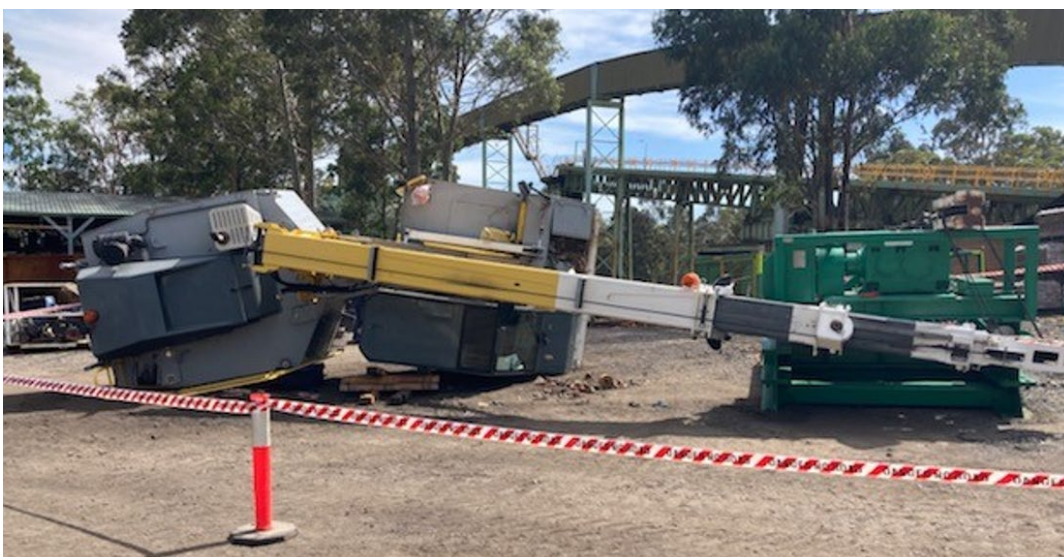
A 25 tonne Franna crane (see figure 1) was being used to relocate a belt winder that weighed approximately seven tonnes. During the relocation, the crane was articulated and slowly rolled onto its side. The operator was uninjured and was able to exit the crane.

*Figure 1 – Franna crane overturned - cause still under investigation.*

A lift permit and safe work method statement were in place for the lifting operation, which included supervision and spotters. Environmental conditions were good and the ground was relatively flat. Witnesses said the belt winder was rigged level when it was lifted. The crane reversed approximately five metres before articulating and then overturning. An investigation found the crane was not overloaded when it was positioned straight but became overloaded when it was articulated to 21 degrees. At this point, the operator ignored an overload alarm during the move. It was later found that crane scales were also inaccurate, significantly underestimating the true load. The operator said ignoring alarms was not an unusual practice to get jobs done.

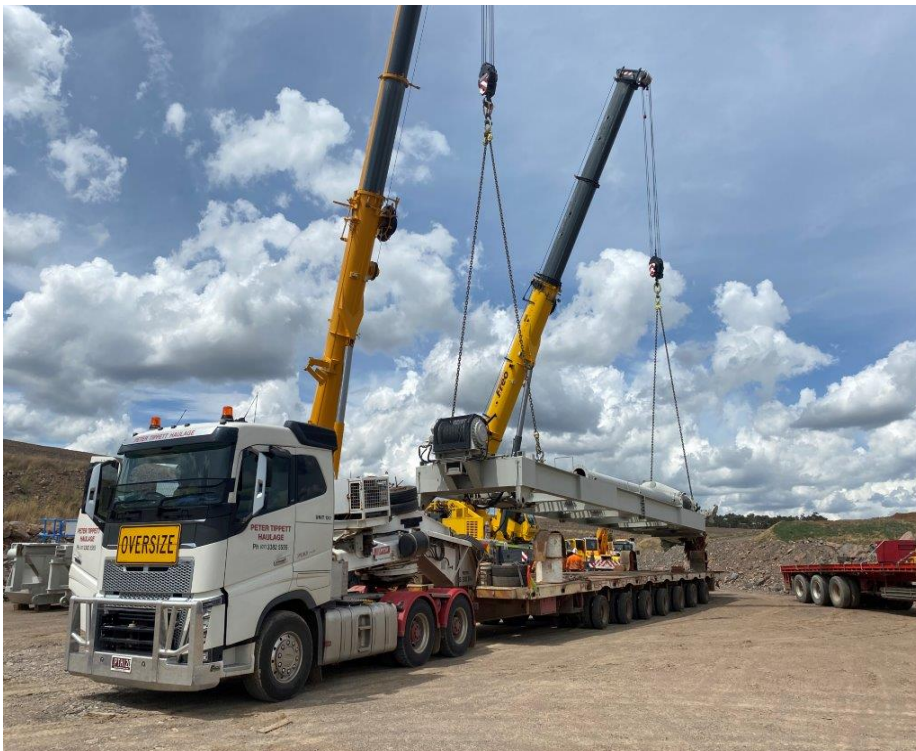
A dredge wheel excavator arm was being loaded onto a heavy transport trailer using two 150 tonne cranes. The operation involved lifting the arm and reversing the trailer under the load. As the weight of the arm transferred to the trailer, rear wheels of the prime mover became unweighted. The truck and trailer then started to roll forward as the rear wheels of the prime mover were the only wheels with a brake applied.

The driver got into the truck and applied the brakes to the trailer after it had rolled approximately three metres. There were no injuries.

*Figure 2 - Truck moved on placement of load*

Despite these processes, and the lift itself being undertaken successfully, the trailer supplied by the trucking contractor was different to the trailer originally specified for the job. It suited the gross mass of the dredge wheel excavator arm being transported but not its physical size or mass distribution characteristics.

Positioning the support frames on the trailer was left to the experience of the truck operator. Because the centre of gravity was so far rearward on the trailer, the upward force at the king pin lifted the unweighted rear wheels of the truck, which were the only wheels with an applied brake.

Furthermore, due to the hydraulic jacking feature of the trailer, it was common practice to not engage the trailer brakes during loading. Commonly, the trailer is raised to accept the load rather than the load being placed on to the trailer with the use of cranes. The wheels must be free to rotate during the jacking operation to avoid brake damage.
