Dangerous scaffold incident

5 October 2023

Incident Information Release

SafeWork NSW

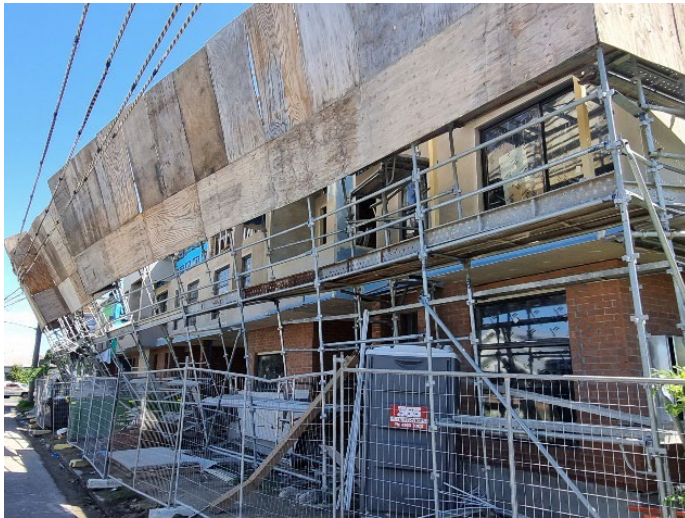
A section of scaffold for a multi-unit residential project has separated from the building face and come to rest against low voltage distribution powerlines. It appears scaffold ties were removed resulting in serious immediate risk of collapse.

Scaffolding looking west

- the scaffold is adequately tied to its supporting structure, in accordance with instructions from a competent person. Consult with the scaffold designer, manufacturer, supplier, or an engineer, and prevent unauthorised removal or changes by workers on site

- to develop systems of work that allow construction activities such as bricklaying, painting, rendering, glazing, and cladding installation to be completed without unplanned changes to or removal of scaffold ties, e.g., relocate ties so they do not interfere with the work. Examples of systems of work, include and are not limited to:

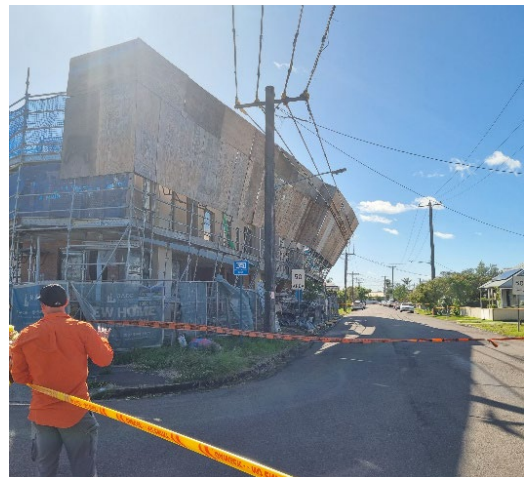
Scaffolding looking east
